Fatal stability loss of a small craft on a wave crest – based on a real safety investigation

ABSTRACT

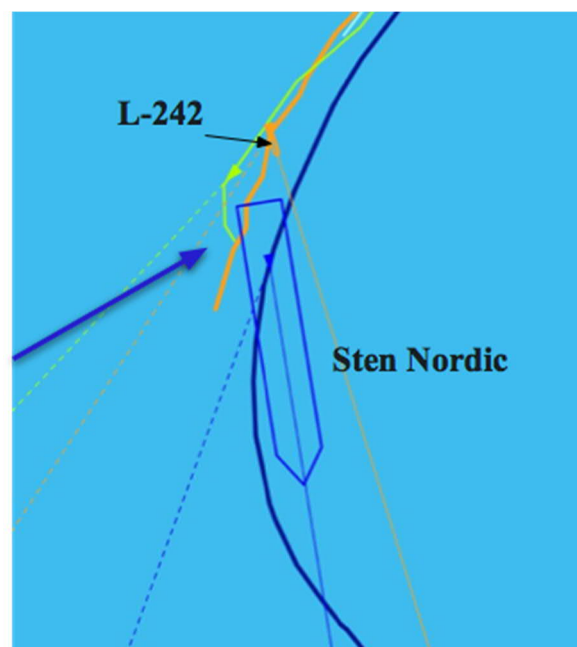
stern of the tanker and became exposed unexpectedly to high, steep recurring waves caused by the combined effect of the vessel and the sea waves. The path travelled both by the tanker and that of the pilot boat *L-242* are shown in Figure 1.

Figure 1: The paths travelled by the tanker and the pilot boat *L-242* shortly before the boat capsizing.

The situation prior to the boat capsizing is shown. The blue arrow depicts the prevailing direction of the sea waves' propagation. The speed of the boat was approximately 9 knots.

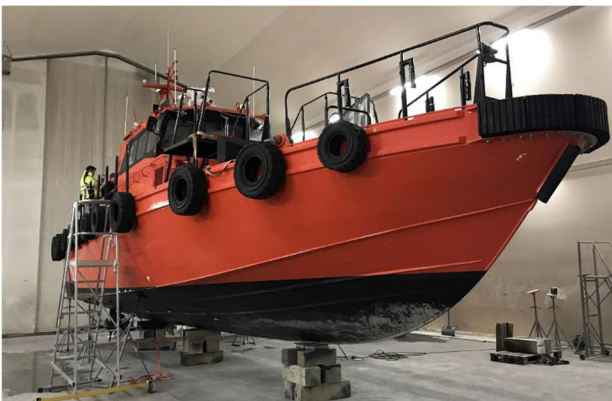
Figure 2: Pilot boat L-242 investigated after the accident. (Source: SIAF)

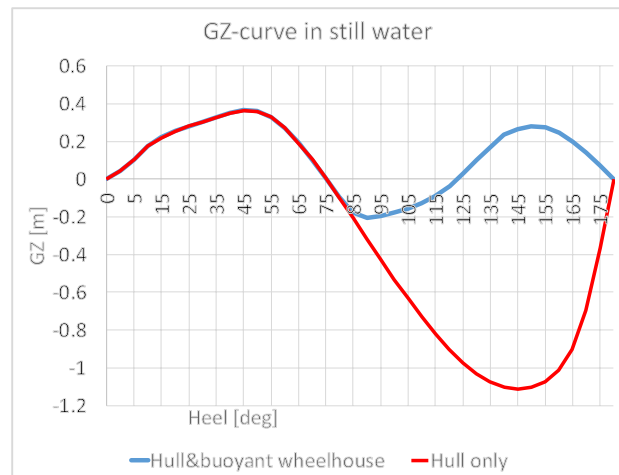
Figure 3: Righting moment curve (GZ-curve) of the pilot boat.

It was observed that the restoring moment of the pilot boat can temporarily lose up to 70% of its maximum in steep waves, during which a sudden, strong external force can capsize the boat. Such an external force can occur due to a rudder movement or a powerful gust of wind. No account of these factors had been taken in the design, manufacture or use of the boat. On the basis of the investigation, there is also reason to believe that the crew of the pilot boat *L-242* had no grounds for believing that the boat would capsize.

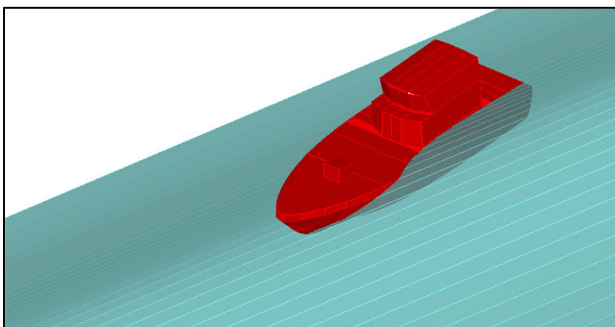
Figure 5: Position of static equilibrium of the pilot boat in regular sinusoidal wave of length 40 m and height 3 m. Heading 50°.

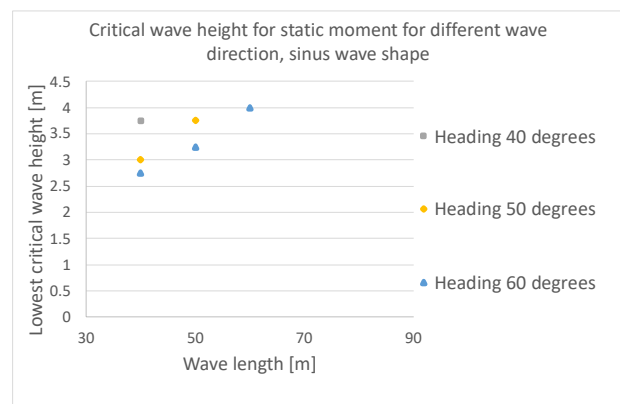
The results of this static, i.e. slowly increasing, loading by rudders on the boat in the critical waves are presented in Figure 6.

Figure 6: Critical wave heights for static loading caused by turning rudders by 40°.

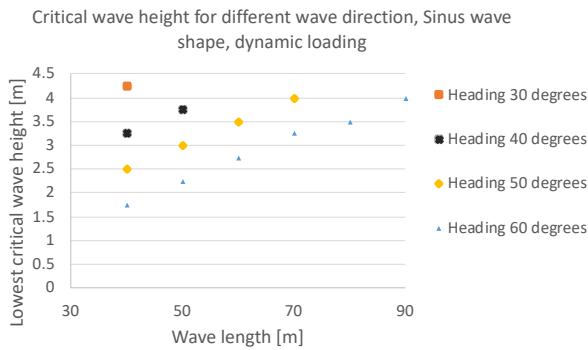
In Figure 7 the critical waves and headings for rapid (step function form) rudder load are presented.

Figure 7: Critical wave heights for dynamic (step function) loading caused by turning rudders by 40°.

It is clearly seen that the dynamic rudder command substantially increases the risk of capsizing. A nearly linear increase of critical wave height with length suggests that wave steepness is the primary reason for capsizing. The critical wave steepness depends upon heading. The most dangerous heading capsizing the boat in waves of smallest steepness is 60°.

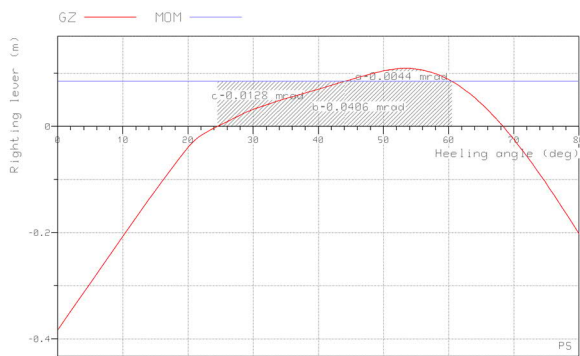
An example of the boat capsizing due to a rapidly changed rudder angle in the critical wave and heading condition is illustrated in Figure 8. The static balance of the boat in this condition yields a heel of 24°.

Figure 8: Dynamic loading due to rapidly turned rudders capsizes the boat in 40 m long and 3.5 m high wave, heading 40°.

A substantial decrease of the GZ-curve maximum, stability range and the capability to withstand dynamic loads is noted. The latter is not enough to resist dynamic load of the rudders.
