Forensic Study of *BOUVET* Capsizing

Abstract: The paper deals with the capsizing of the French pre-dreadnought *Bouvet* during World War One (WWI). If the circumstances of the drama were clear, the reasons for the capsizing -- both concerning the stability of the ship and the nature of the device -- were not, and few hypotheses can be found in the literature. The aim of this work is to clarify those hypotheses and to test modern tools against this rather well documented event. For that purpose both numerical computations and experiments have been planned. Part of them have been performed and reported in the present paper.

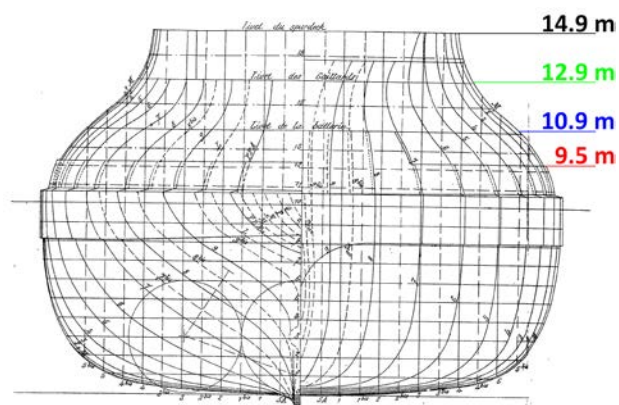
As shown on figure 1, *Bouvet's* hull form is characterized by considerable tumblehome and with a counter stern, seen today in the US destroyer DDG 1000 *Admiral Zumwalt*.

Fig.1: battleship *Bouvet* hull form.

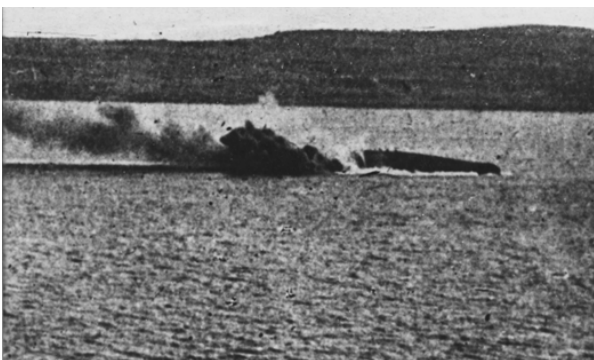
This case study is very interesting because the ship sank in well-known conditions (there are even pictures of the disaster, see figure 3). Also, this case was among those of several other warships whose rapid capsize was to prove the necessity of developing damaged stability rules for warships.

Fig. 3: Picture of the capsizing of *Bouvet* the 18th Mars 1915 taken from HMS *Agamemnon*.

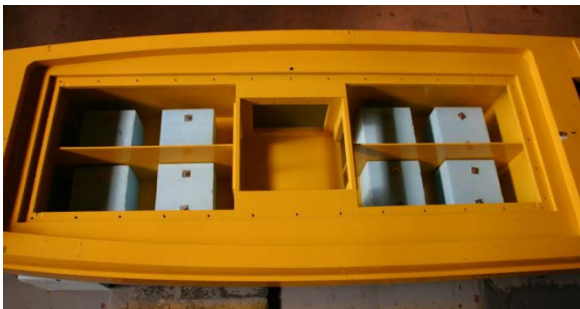
A four-meter long model of the *Bouvet* was built and the static stability fully explored. Experiments have been performed in calm water without forward speed. The progressive flooding represents different configurations and internals arrangements. Experiments and numerical calculations have been performed on different cases. A view of the internal arrangement in the workshop is shown on figure 5 where the two starboard boiler rooms separate by a cofferdam (on axis) and starboard 274 mm ammunition room can be seen.

Fig. 5: Internal arrangement.

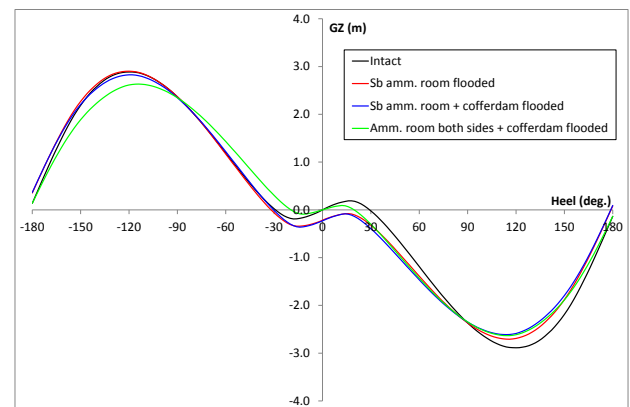
Fig. 10: GZ curves for watertight deck positioned at 10.5 m.

It can be seen that whatever the hypothesis the capsizing was certain; the only equilibrium position corresponds to 175° of heel. The experiments will give an insight, using the time to sink, to define the right hypothesis.

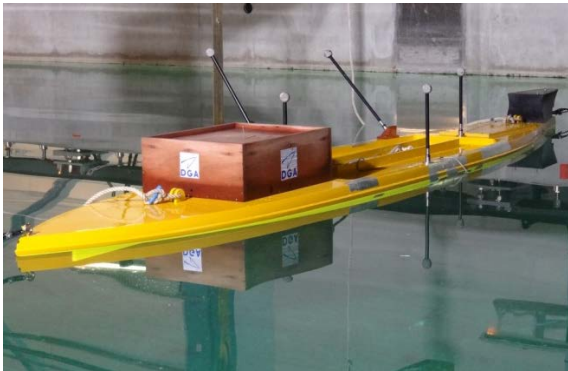
The model allows a modification of the internal arrangement that can lead to different flooding configurations. The model is shown on figure 12.

Fig. 12: Model during tests in the tank.

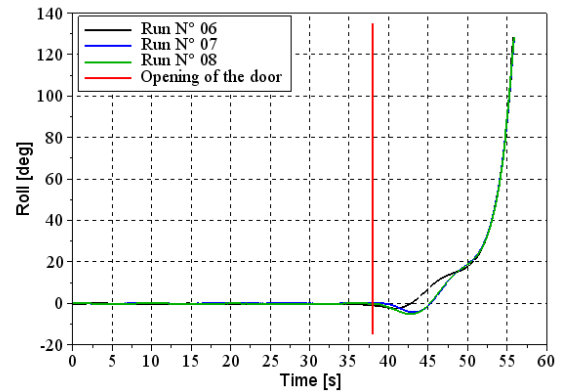
At this time, only succinct analysis has been performed. The repeatability of the measurement has been checked and is quite good as shown by figure 13. The heel angle versus time is reported on figure 13.

Fig. 13: Time history of the capsizing in case 2.

The roll angle was measured until a heel angle of about 130 degrees after what the markers are underwater. In case 2 the time to reach this angle is about 18s while 55 s have been reported by witnesses. Even if they report the duration of the full reversal – and not only till 130deg – the difference is quite large. As we can see on the figure 13 after beyond 20 degrees heel angle the capsizing speed increase a lot. One could expect that after 90 degrees the deckhouse – not represented on our model – enter the water and slow down the motion because of drag effect and air locked in the decks.

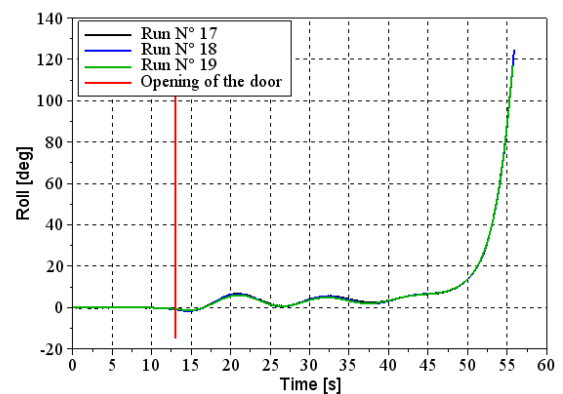
If we now look at the results obtained with case 5 – a less favorable case as more compartment are flooded – but with a smaller opening size we can see that the capsizing time is closer from the 55s.

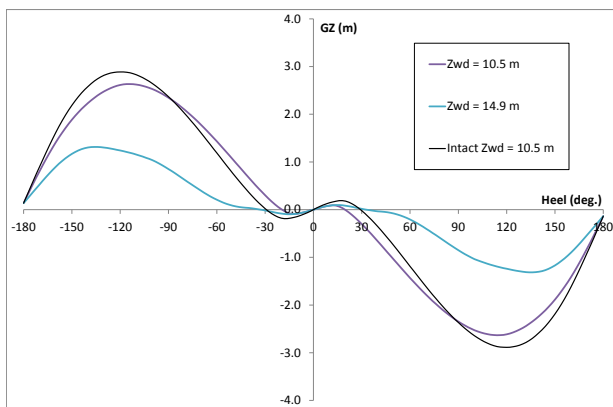
Fig. 14: GZ curves with a cross flooding duct.

Nevertheless the positive area under the curve is so tiny that the dynamic force of the capsizing would have overcome this feeble stability and led to capsize. Moreover, even had the ship been fitted with cross-flooding ducts in the three compartments, the dynamic nature of the flooding would still have led to the capsizing of the *Bouvet*.
